305(b)/303(d) Water Quality Integrated Report to Professor Lau
for the Period of August 12, 2020 and November 20, 2020

Nicolas Loudermilk, Chasity Tompkins, Reneisha Leeper, Samantha Houck, Kristin Ransome

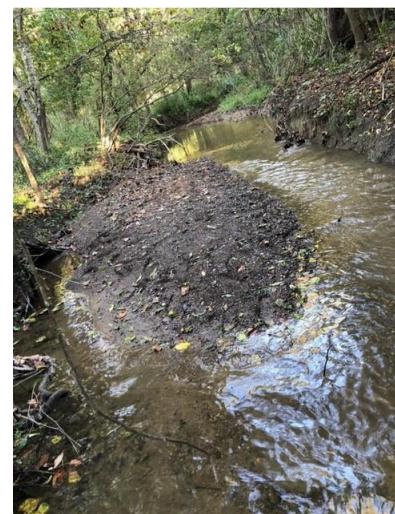
Figure 3. Example of gravel pit within the Stream.

Next, the physical landscape was given a status of indeterminate (table 4) because there were some portions of the stream that did not support life (e.g., unbalanced pool/riffle ratio, high fine sediment, etc.) while other parts did (e.g. lots of canopy cover, lots of organic material in some portions, sinuous stream pattern, etc.). One example of a physical characteristic that impairs the stream, as seen in figure 3, was large gravel beds in

Connelly's Run. Also, turbidity of the water was impaired, as it is supposed to be above 120 mm, but it was 53 mm (table 1). Because of the indeterminate status for the physical habitat, more sampling in the future would be needed in order to keep a careful watch. This watch is necessary to help make sure the physical habitat's health does not decline.

One way we can improve Connelly's Run is by limiting the total maximum daily load (TMDL) of nitrate. This limitation can be done by reducing the amount of harmful runoff from farming, reducing traffic in the landfill area, and limiting how often trucks drive through the water. For example, growing native plants around the stream, especially in areas where the stream has no canopy cover, would help uptake some of the nitrates entering the stream and provide more macrohabitats for the organisms in the area. To continue describing, planting these

native plants could help with the issue of turbidity as the root systems of these plants will help reduce erosion along the banks. Also, limiting human traffic near and in the stream would help reduce the amount of debris entering the stream, and probably increase the health of the overall stream.

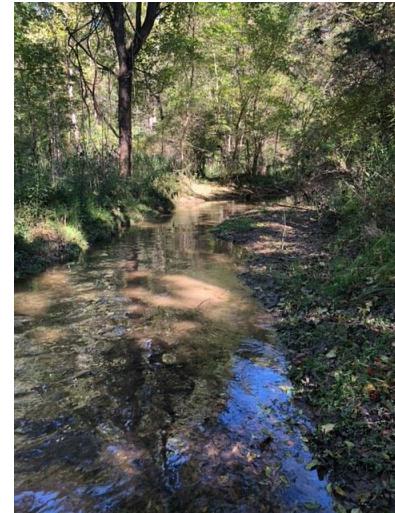
Figure 4. Wondering pattern characteristics seen within the stream

Castillo (2007), the velocity of the water at Connelly's run is too slow to move sediments that has a medium to large D₅₀, where the D₅₀ of Connelly's run is considered to be about the size of course gravel. For exact physical measurements, table 1 represents measurable physical characteristics that was calculated during the stream assessment. For example, the average depth of Connelly's Run was about 136.72 mm, while the stream also had an average wetted width of 3.47 m. To summarize, Connelly's run is a first-order, pool/riffle stream with wandering channel patterns, where this part of the stream is a depositional zone of relatively large sediments.

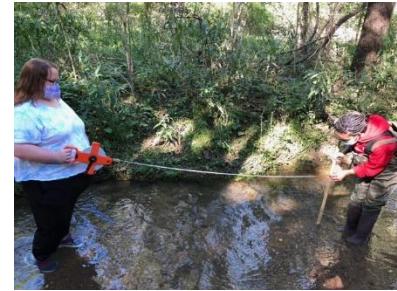
Figure 5. Example of the longitudinal profile being taken.

The longitudinal depth of the water (mm) and channel unit classifications (e.g., riffle, pool, or glide) were measured longitudinally in the Thalweg, which represents the flow of the water. Depths and channel unit classifications were measured at equidistant locations from Transect A to K. These distances were determined by dividing the transect length (m) by 10 (i.e., dividing the reach length by 100). Figure 5 shows an example of using the calculated distance between each section of the transect to calculate the Thalweg at Connelly's Run.
